## DHV Accident Report 9.01.2011

Date	18.12.10	Time	15:15:00
Land	Germany	Site	Brauneck
Pilot	32 years old, DHV A-Licence since 2004	Experienced Acro-pilot	
Equipment: PG	U-Turn Thriller 20m <sup>2</sup> acro glider	Tested by	Not tested
Weight range	90-120kg	Pilot start weight	
Harness	Ava Sport Acro with foam protector and 2 underseat reserve containers	Reserve	1. Team 5 Orange ST steerable 2. Independence Seven Up L
Pilot Injuries	Fatal	Passenger Injuries

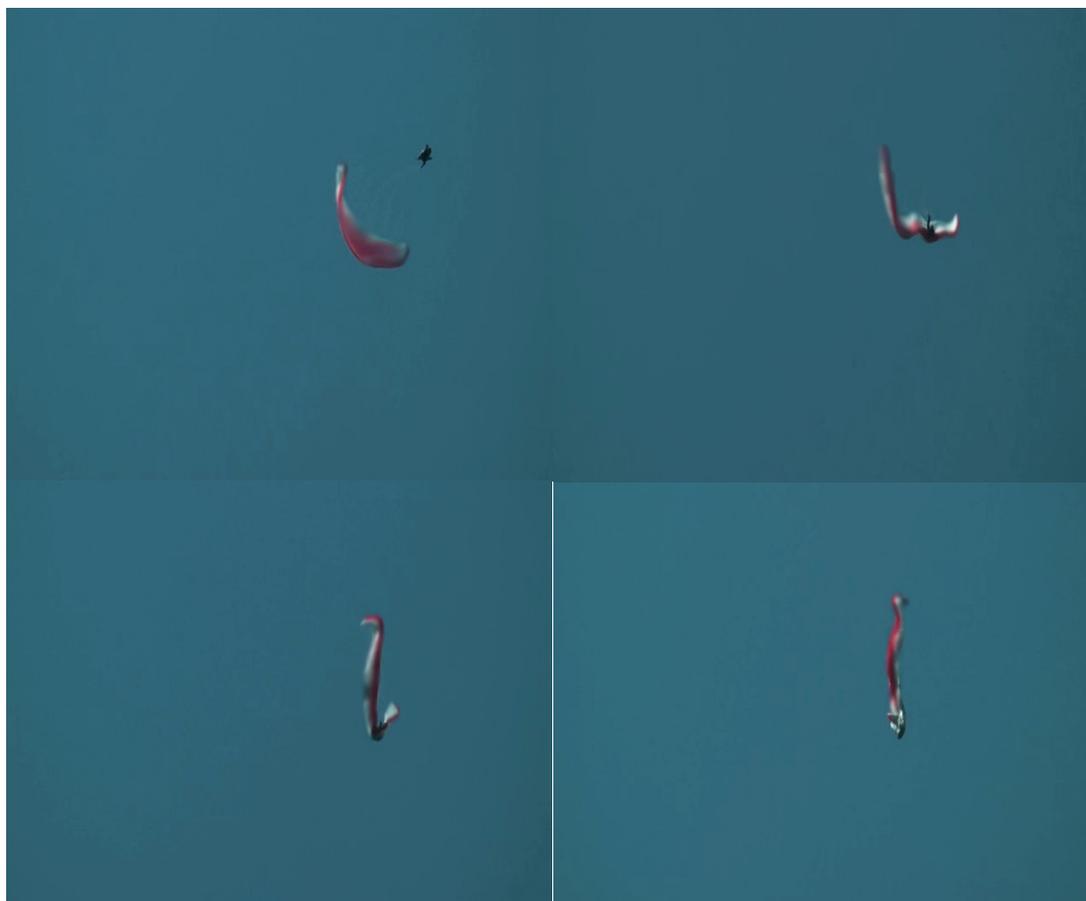
*Pictures 5-8: these pictures (of a different accident) indicate the sequence of events. Top left: the pilot begins to fall towards the glider, contact with the canopy after 0.7 seconds (top right). At this moment the reserve deployment was witnessed. The reserve became tangled in the main canopy as it rose up asymmetrically within a further 0.3 seconds (lower left) and did not open correctly due to this. Lower right: the pilot is completely wrapped in the glider and falling at high velocity to the ground.*
