## Safety notice UP 2019-01

**Publication date:** July-11-2019

**Subject:** Trim of Ascent 4 and Mana

### Concerned products: Ascent 4 and Mana

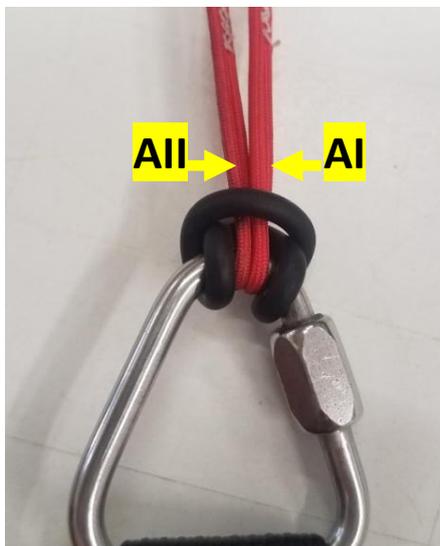
**Before:** AI and AII line have 0 trim loops

**AI, II – Left Riser (Right riser similar): Loops before and after the measure**

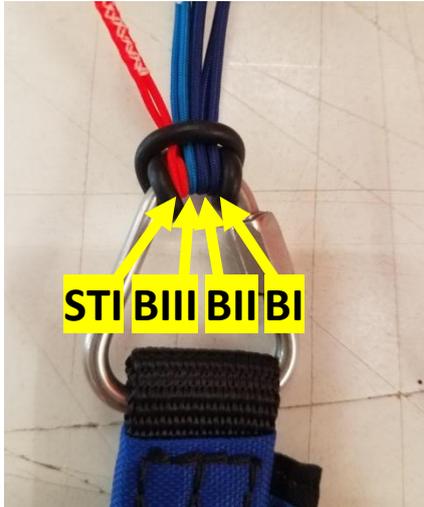
**Before:** BI,BII and BIII have 0 trim loops  
 STI has 1 trim loop

**BI,BII,B III, STI – Left Riser (Right riser similar): before and after the measure**

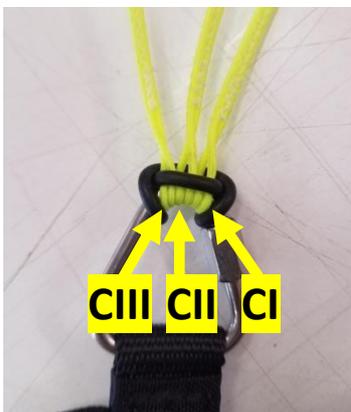
**Before:** CI,CII and CIII have 1 trim loop

**After 20 flight hours the loops on CI, CII and CIII must be released:**

**CI,II,III – Left Riser (Right riser similar): Loops before and after the measure**
