**Accident report of the German paragliding and hanggliding association (DHV)
from October 5th 2021**

Date	August 12th 2021	Time	around 2:30 pm (local time)
Country	AT	Site	En route, Tennengebirge
Pilot	German; 59 Years old; experienced competition pilot; member of the German paragliding league		
Equipment PG <input checked="" type="checkbox"/> HG <input type="checkbox"/>	Gin Gliders Leopard L, EN/LTF D	Laboratory	DHV
Weight range	105-127 kg	Take-off weight pilot	unknown
Harness	Kortel Kanibal Race 2	Reserve parachute	Finsterwalder Diamond Cross 125 ST
Injuries Pilot	Fatal	Injuries passenger	-

A fatal accident occurred during the paragliding competition "Ikarus Open", which is held annually in Werfenweng / AT. A German league pilot fell into a spiral fall with a cravat, presumably as a result of a collapse. The reserve parachute, deployed very late, did not open. The pilot fell into high alpine terrain and suffered immediate fatal injuries on impact.

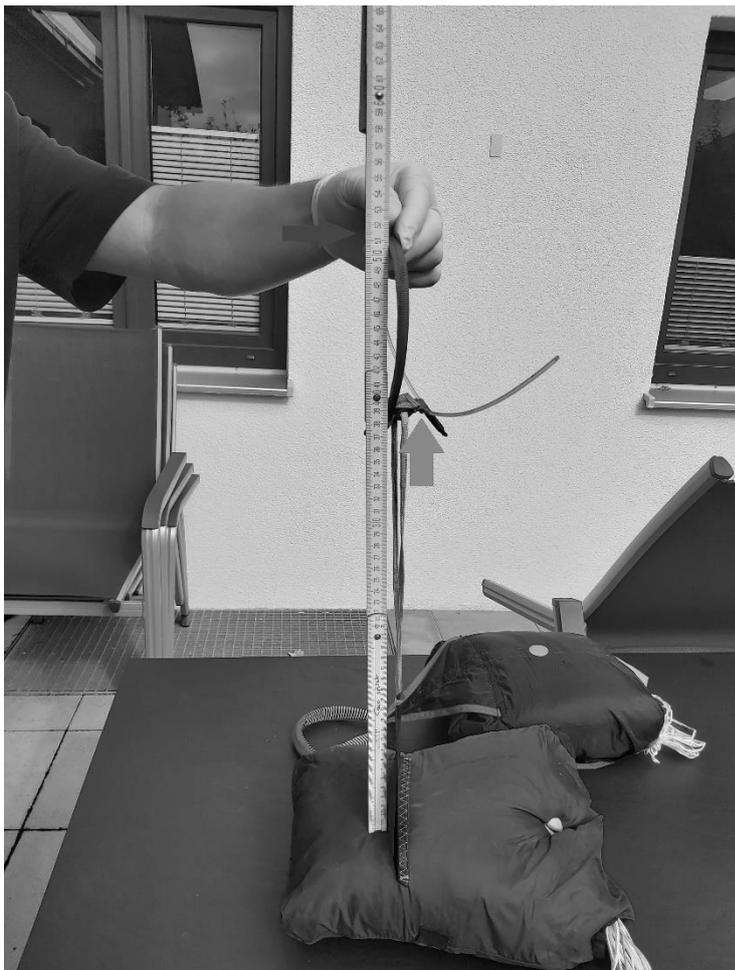
Picture 1 shows the length of the connection of 52 cm between the handle and the inner container (horizontal arrow) and the stiff strap that protrudes at right angles to the split pins (vertical arrow). In the background is an inner container of a different design with a much shorter length of less than 30 cm between handle and inner container.

The reserve parachute, Finsterwalder Diamond Cross ST 125, is a steerable rescue parachute. The inner container is constructed in such a way that after the throw the suspension lines are released first, but the rescue parachute remains in the container. The container is only fully opened, and the reserve parachute released after the last suspension line has been stretched. That did not happen in the accident. The reserve parachute did not come out of the container before impact. An eyewitness saw the inner container, which was still locked with the last suspension line, when unloading the accident equipment from the helicopter. At the DHV, however, the reserve parachute arrived with the inner container open (but mostly in a packed state). The loop for looping the release handle is attached to a triangular cloth of 10 cm length on the inner container. This extends the connection between the handle and the inner container to 52 cm (see Pictures 1 and 2).

1. State-of-the-art technology for the length of the connection between the handle and the inner container is a maximum of 30 cm. Modern, harness-specific inner containers also do not have a thin connecting line, but instead a short fabric triangle which, due to its short but wide design, cannot loop around the suspension lines of the reserve parachute.

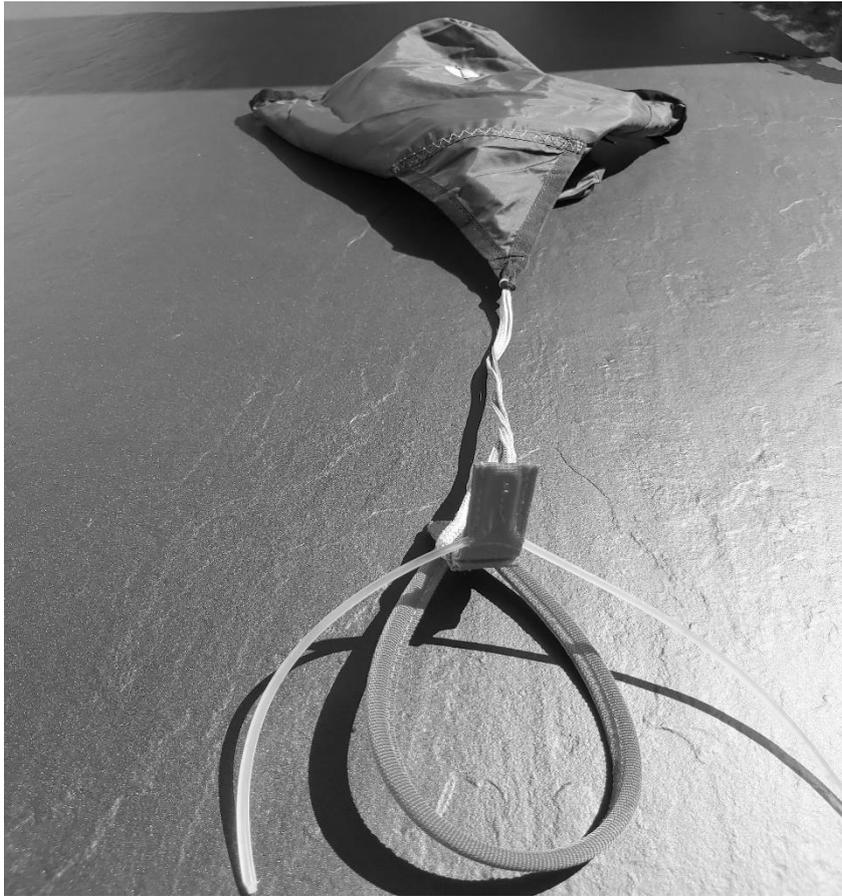
Picture 2 shows the deployment handle of the harness and the long connecting line to the inner container of the rescuer. The connection is also lengthened by the triangular cloth on the inner container.

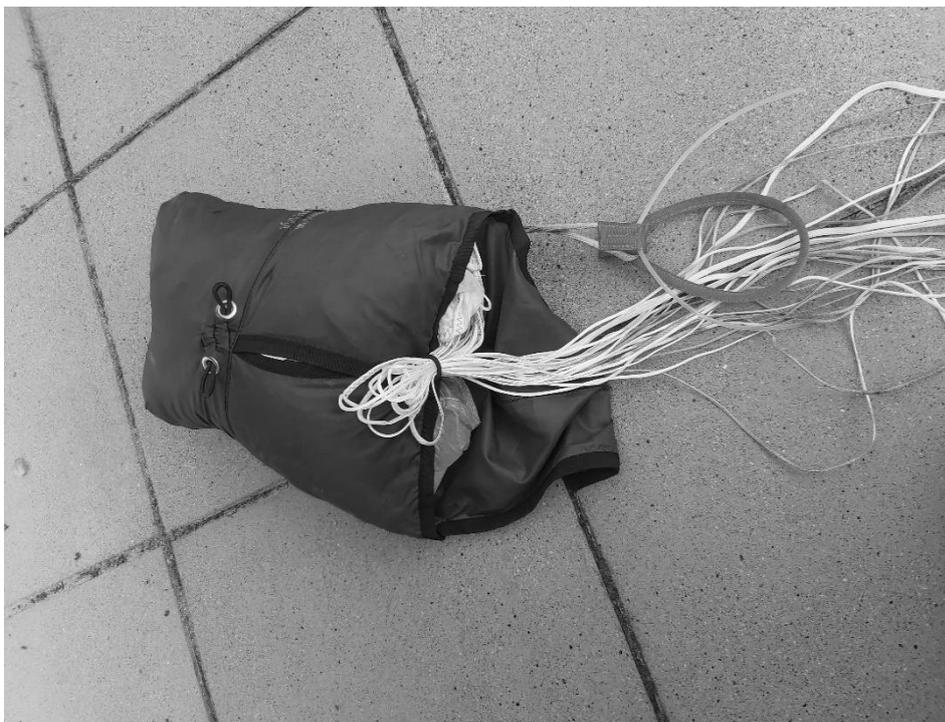
Picture 3 shows that the length of the connecting line bring the heavily structured handle into the area of the released suspension lines before the reserve parachute is released.

3. The case also shows that the connection between the handle and the inner container should not be so long that when deployed it can reach the area of the opening bundle of suspension lines.

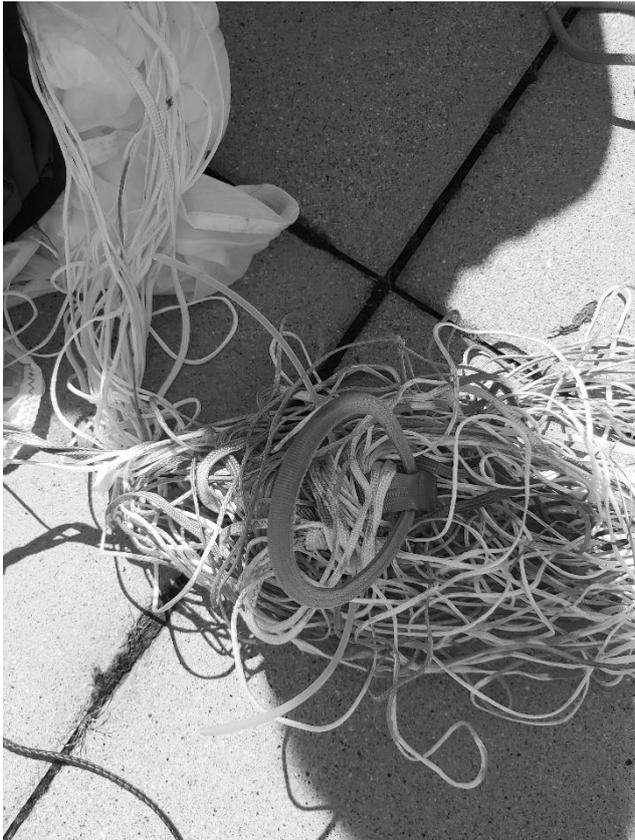
Picture 4 shows the strong and firm entanglement of the handle with the suspension lines of the reserve parachute. The accident equipment arrived at the DHV for investigation in this condition.

After the reserve parachute was deployed, the inner container was prevented from opening and releasing the reserve parachute. The observations of the eyewitnesses and the technical investigation have given clear indications that the reason for the failure to open was an entanglement of the release handle with the suspension lines of the reserve parachute. This entanglement prevented the last suspension line from being pulled, which prevented the container from opening. **Note: See supplement 8.10.2021, page 7**

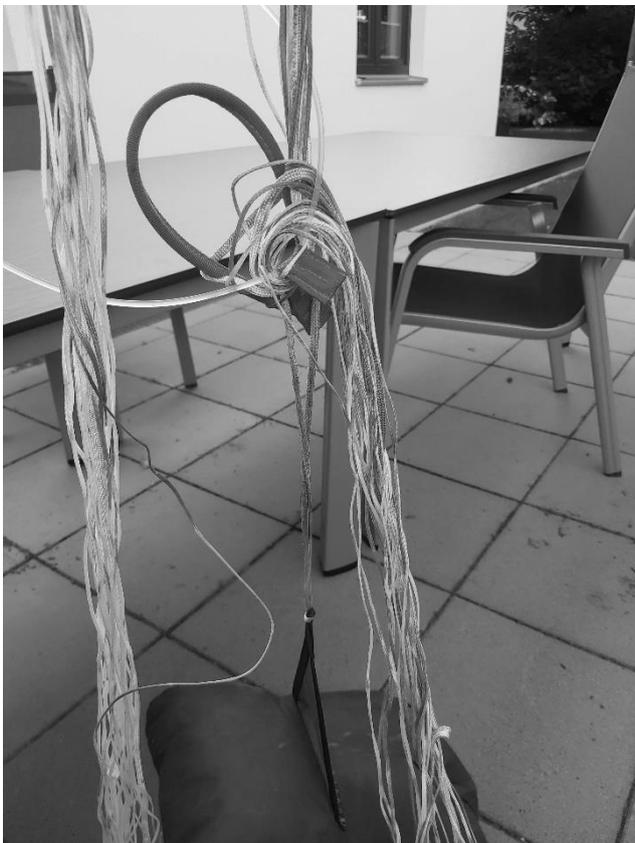
Picture 5 shows that the heavily structured release handle can cause a strong tangling / twisting with the reserve parachute 's suspension lines relatively easily and reproducibly (simulated).

- Make sure that rescue device release handles do not have any stiff or protruding components that could become entangled /looped with the reserve parachute's suspension lines.

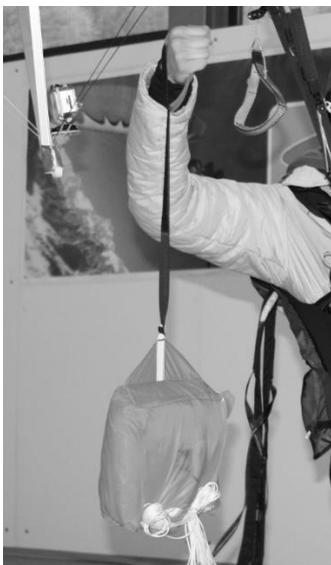
- A long haul is necessary before the inner container can be released from the harness container. With a 50 cm connection, around half of the arm span is required to pull it out - forcefully throwing the inner container away is not possible with the remaining arm span.
- The long connecting line is potentially dangerous because the deployment handle can then become entangled with the lines of the reserve parachute, as it probably happened in the present case. Entanglements with a riser or around the pilot's hand have also become known in the past with very long connecting lines.

Picture 6 shows that a long connecting line from the handle to the inner container makes it difficult to throw the container because only a small arm span is available.

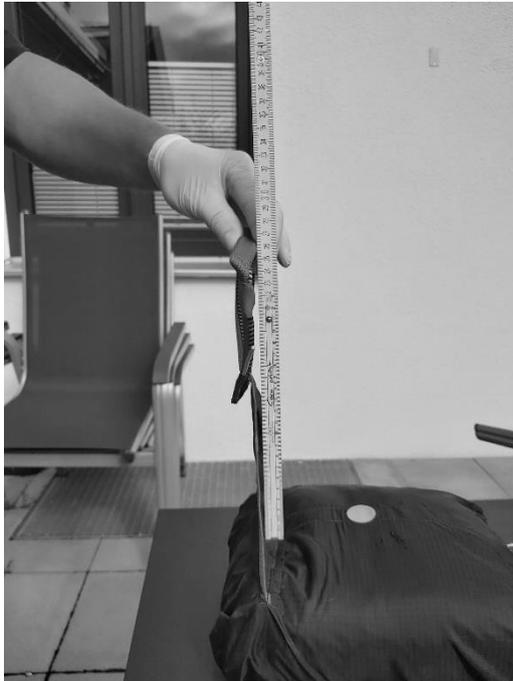
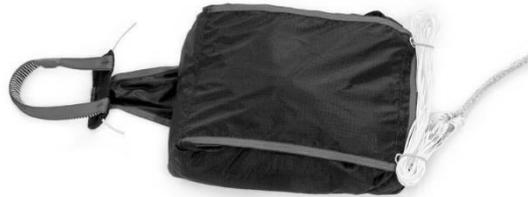
Pictures 7 and 8 show modern harness specific inner containers with a length of well under 30cm between the handle and the inner container with a fabric triangle instead of a thin connecting line.

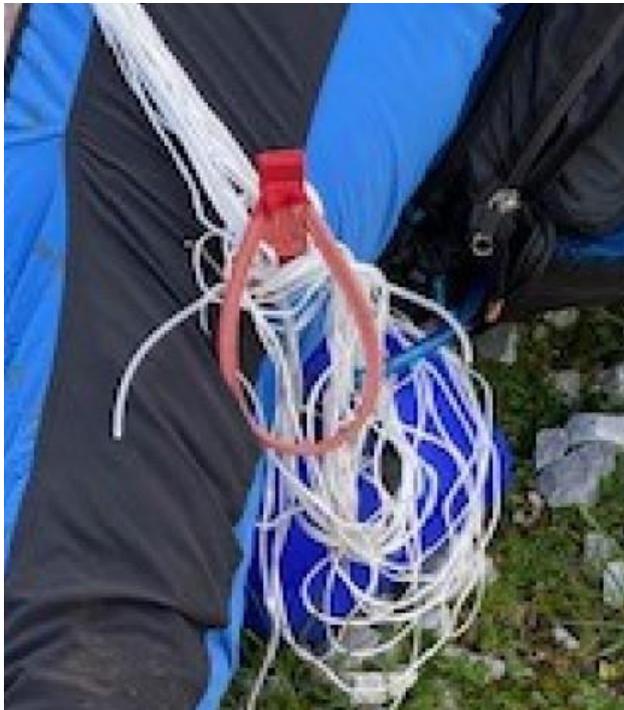
A photo of the unchanged accident site, only now available, shows the entanglement of the connecting line and deployment handle with the reserve suspension lines and the unopened inner container.
