Deutscher Hängegleiterverband accident report 4.02.2011

Date	18.7.2010	Time	21:20
Land	Denmark	Site	Lökken/Lygnby, Danish West coast, soaring
Pilot	M, 42 years old, experienced Pilot, PG- Licence since 1995, PG-Instructor, Flying school manager		
Equipment PG <input type="checkbox"/> HG <input type="checkbox"/>	Skywalk Cayenne L, LTF 2 PG; Manufactured 8/2003, last checked 4/2007	Testing Centre	DHV
Weight range	105-130 kg	Start weight	approx. 130 kg
Harness	-	Reserve	-
Pilot injuries	fatal	Passenger injuries	-

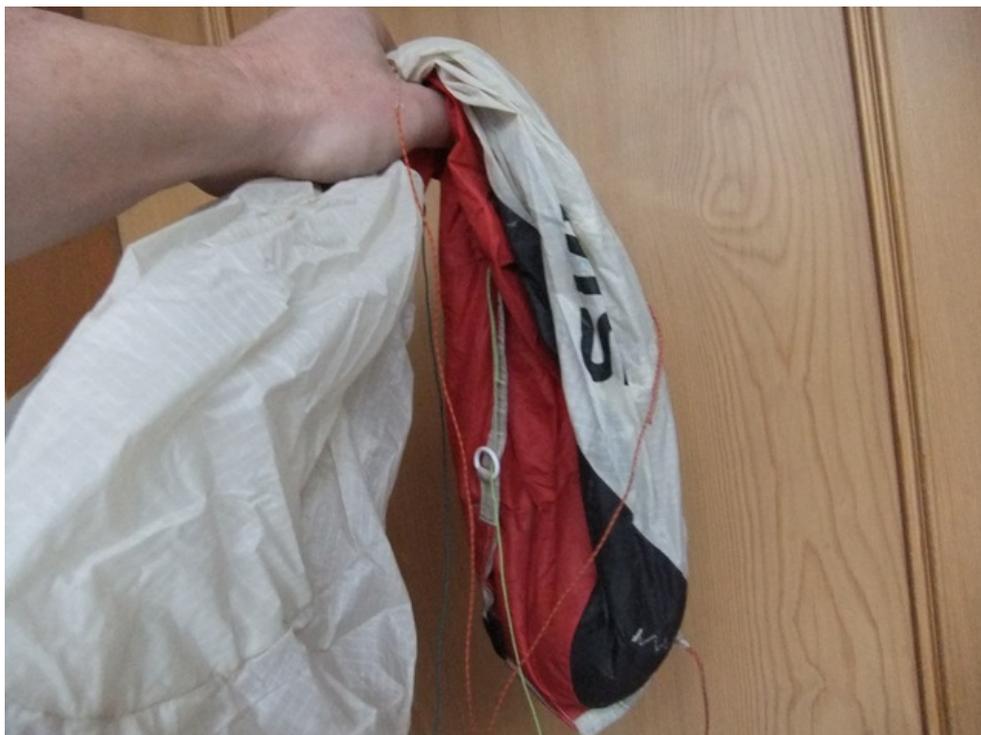
Investigations by the Danish association had revealed the presence of a large quantity of sand in the right hand stabiliser of the glider. 2-3kg of sand is mentioned in their accident report. The DHV measured the weight difference of the accident glider with the archived test example of this glider – difference 2.6kg. The sand in the right hand stabiliser weighed 1.6kg, while that in the left hand stabiliser weighed only 200g.

Picture 1: Right hand stabiliser of the accident glider containing approx. 1,5 kg sand.

There was found 2-3 kilograms of sand in the right wing-tip, that is assumed to have been in the wing during flight, as any sand picked up by the canopy during the rescue attempt will not have collected in the wing-tip but instead would have lain in the cells that it entered, and the model flown has 5 closed cells in each wing-tip, so it is not possible for the sand to have entered these cells directly.

DHV investigations confirmed the Danish reports. After the crash, sand in the middle of the glider would have had to work its way down through all the ribs to get into the stabiliser. This cannot be accounted for merely by the salvage of the glider at the accident site. It can be assumed that the glider contained between 1.6 and 2.3 kg (DHV and Danish measurements) of sand in its stabiliser at the time of the accident.

Test flights conducted by the DHV with the accident glider indicate that large quantities of sand in a stabiliser significantly increase the danger of a cravat which is difficult to recover from. It is most probable that this is the case for other makes and models of gliders. Pilots flying at coastal sites, sand dunes or other sandy areas should recognise this danger and take steps to prevent significant quantities of sand from collecting in the glider stabilisers. Gliders must be regularly emptied of sand.

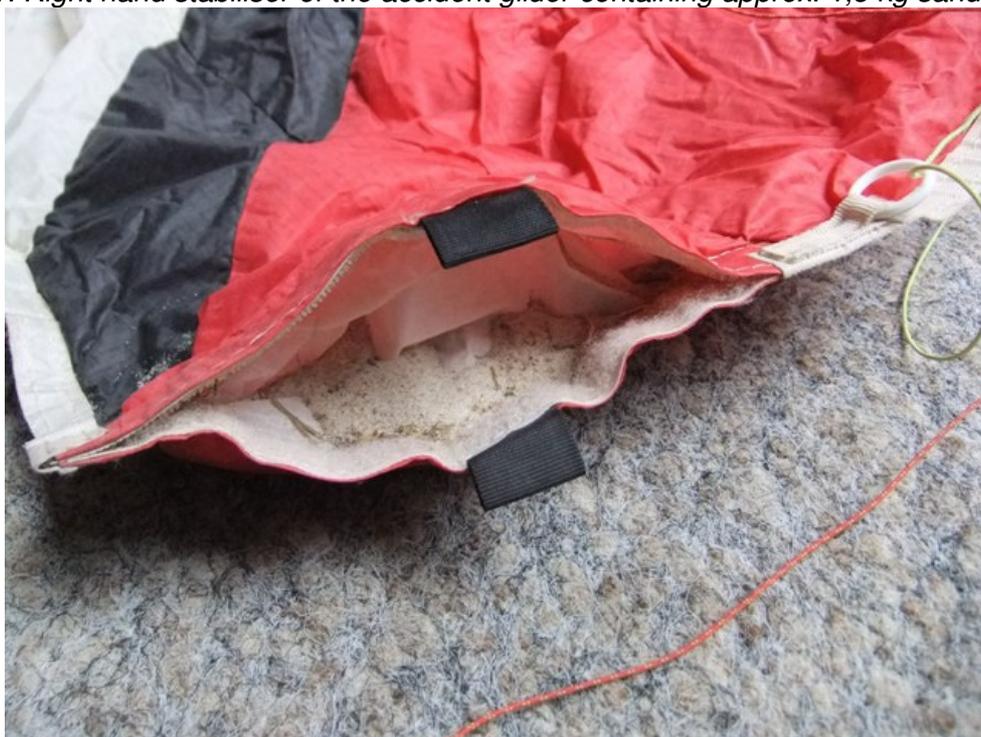
Picture 2: The sand could have been easily removed via the Velcro opening on the glider.

Openings at the end of a paragliders stabilisers are most helpful to aid the emptying of sand from it. (See picture 2). Emptying the sand through the internal ribs is particularly difficult for glider which have closed cells at the wing-tips.

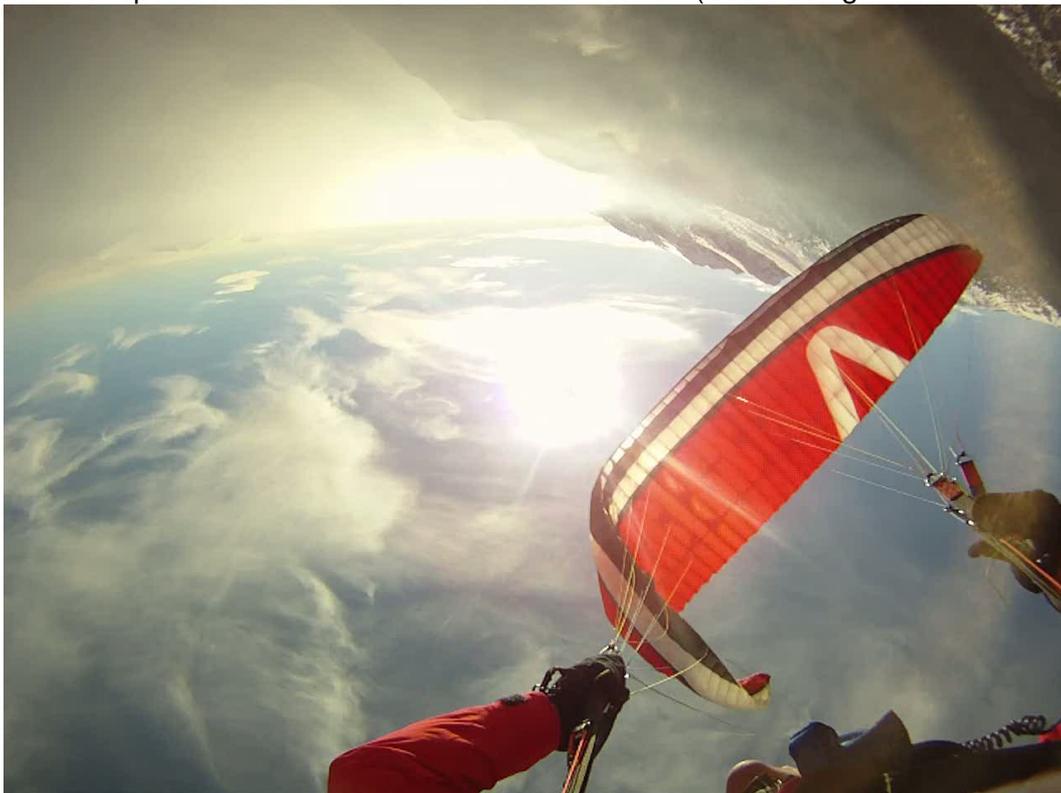
Following this, test pilot Reiner Brunn conducted test-flights at lake Garda. During normal flight no negative effects were noticeable: flight tests starting, straight flight, turning, checking the brake travel distance and tendency to enter a spin were all normal. Recovery after collapsing on the sand-filled side was slightly delayed, with more tendency to cravat. Flight characteristics were markedly different when flying wing-overs – the manoeuvre performed at the time of the accident. Even at moderate roll angles the right-hand side of the glider collapsed easily when this was on the outer side of the turn. Following this, the sand-filled stabiliser became severely tangled within the outer lines. The glider then turned immediately and rapidly towards this cravat. Immediate response from the test pilot was required to prevent the glider entering a spiral dive. This test was repeated several times with identical results. (See test flight videos 1 and 2).

Picture 3: Outer wing tip collapse during wing-over manoeuvre.

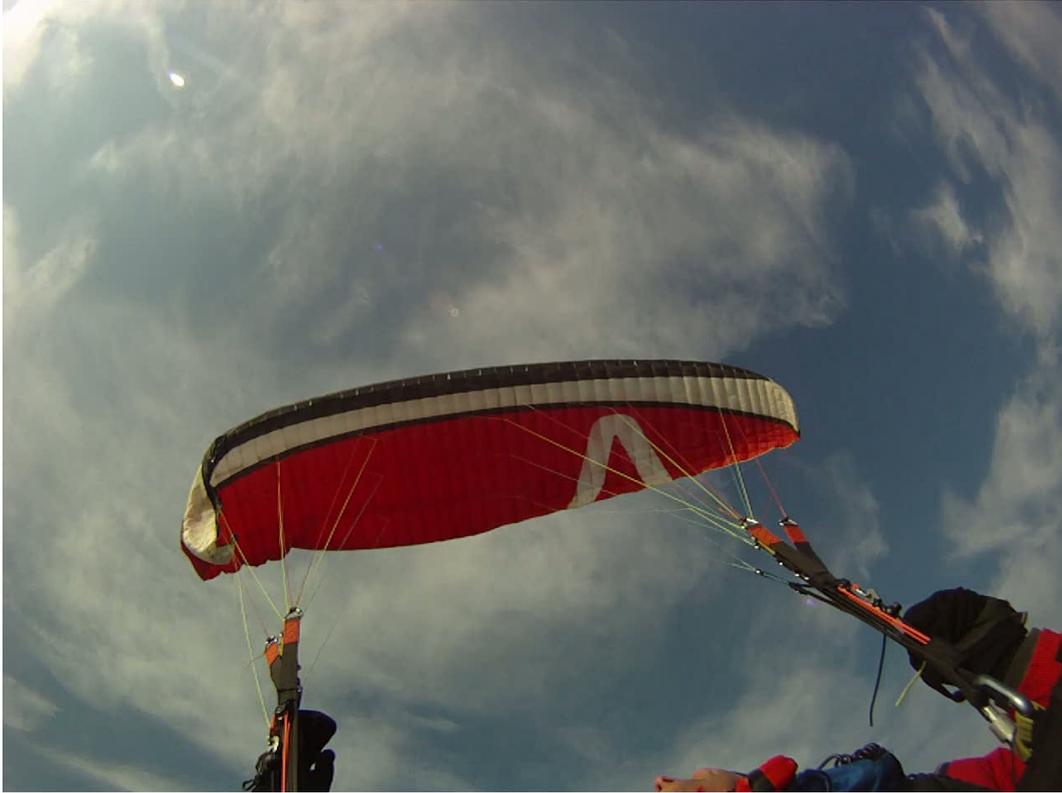
Picture 4: Cravat on the right hand stabiliser, the glider rapidly turns to the right.

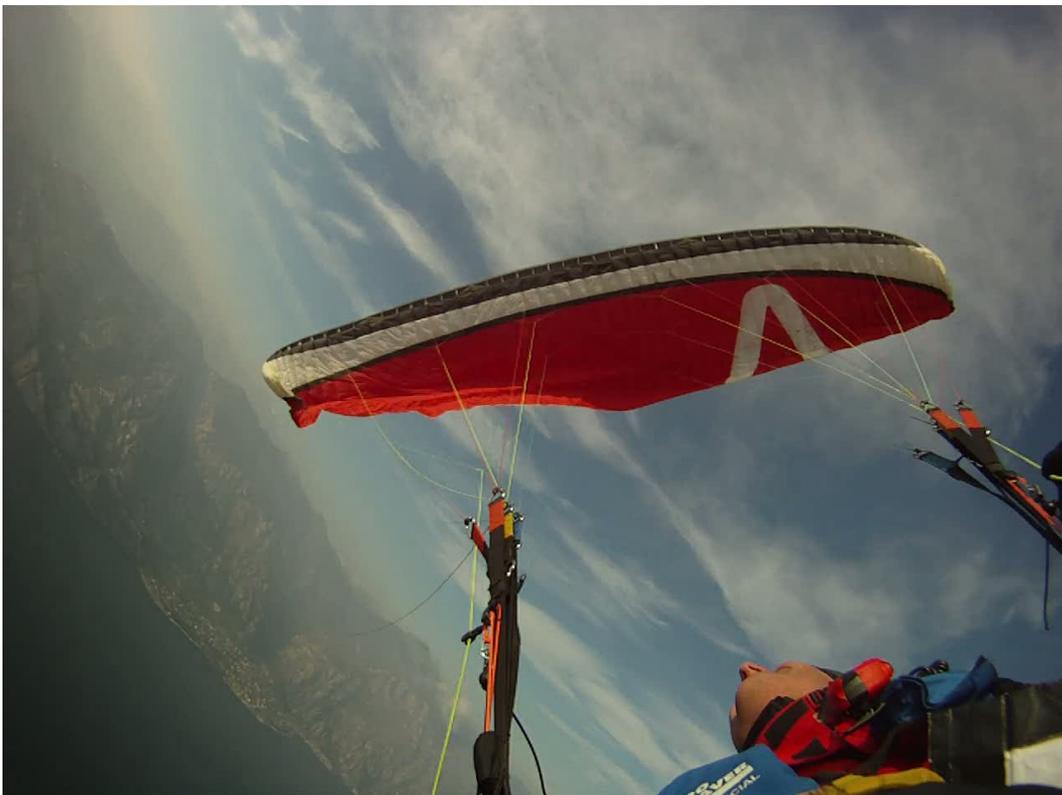
Picture 5: Active recovery required from test pilot to release cravat and stop the dive.

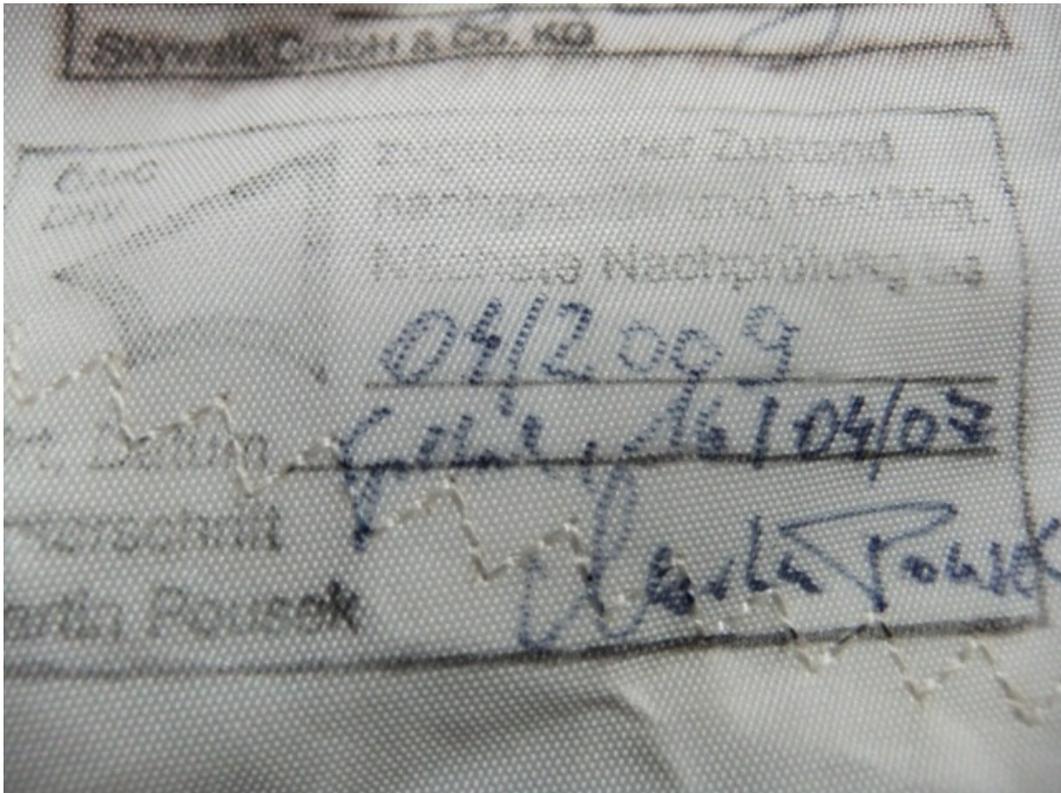
Picture 6: Check label on accident glider

The glider had had its last check in April 2007, which was valid until April 2009. Further checks are not noted on the glider. It is not known if the pilot had checked the glider himself at a later date. Checks by the manufacturer did not indicate that the glider was not airworthy (aside from the sand in the stabiliser).
