## Safety Warning: A.I.R. Atos

This safety warning applies to all models of the A.I.R. Atos rigid glider.

DHV Safety and Technology Department

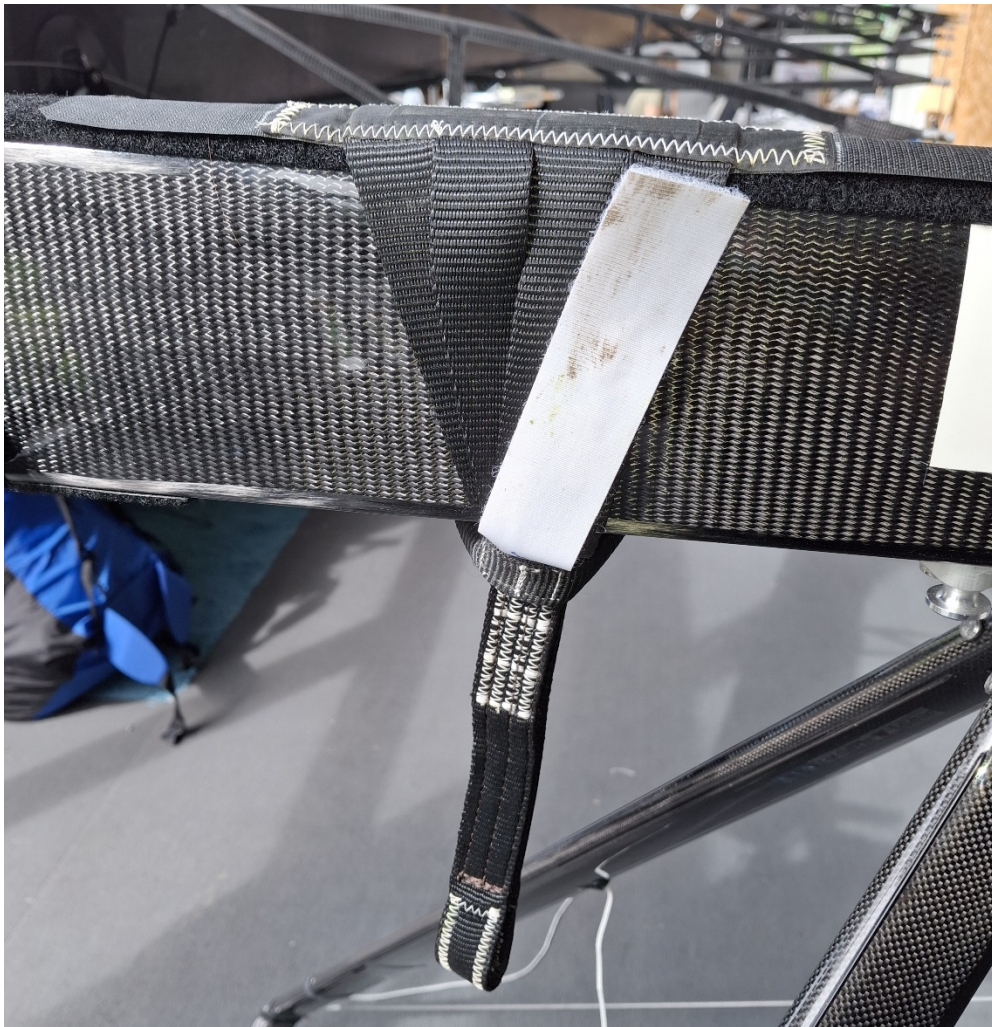
*Figure 1: Correctly fitted and secured main suspension*

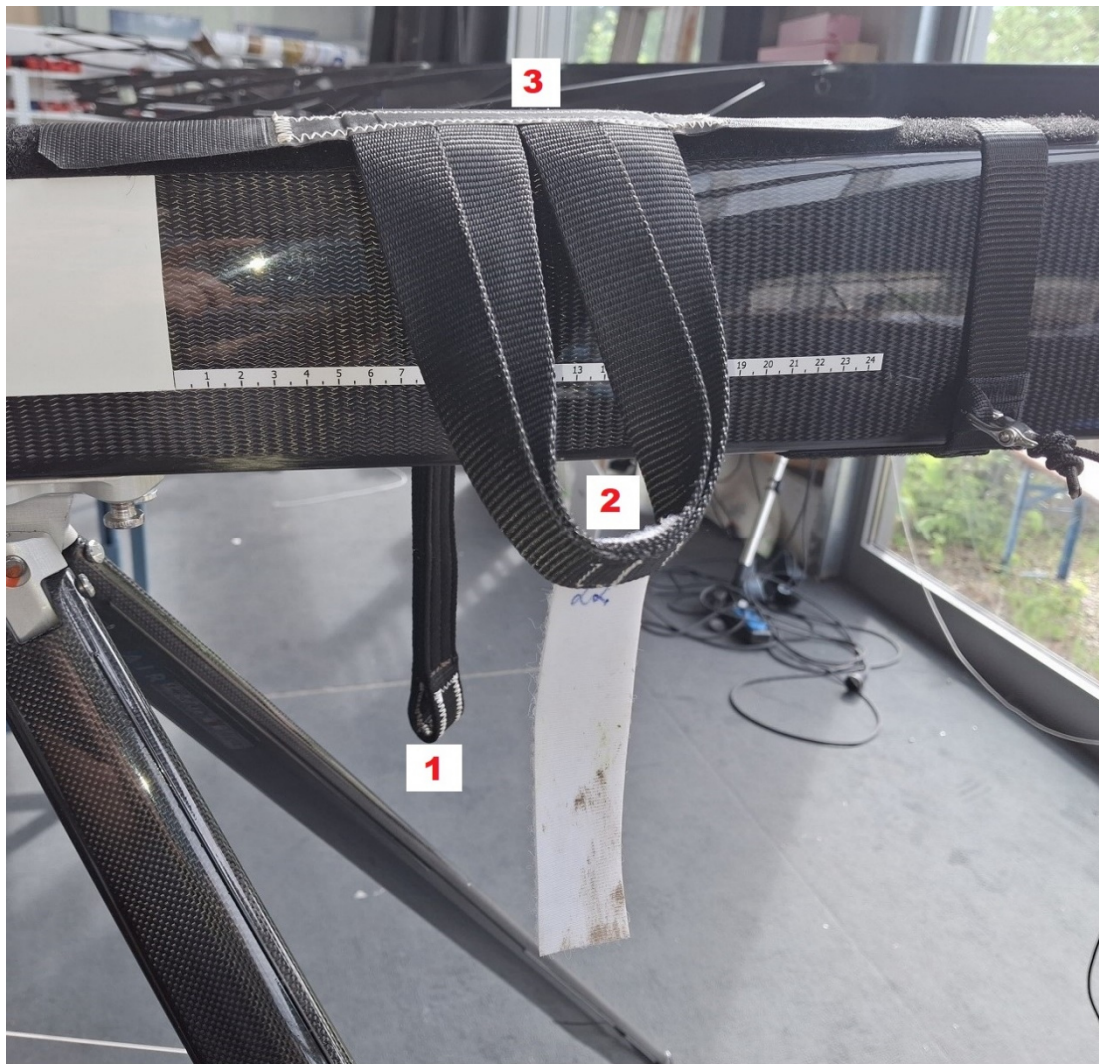
In June, a fatal accident occurred involving a Japanese pilot whilst taking off from the launch site at Buchenberg (Bavaria, Germany). The main suspension had become detached from the Atos's keel tube. As a result, the pilot, who was in his harness, became separated from the glider and fell onto steep terrain. The investigation revealed that the main suspension had not been correctly attached to the keel tube. Photographs taken at the launch site prior to the accident flight showed that the Atos in question (a glider on loan from the manufacturer) had initially been fitted with a correctly installed suspension. The pilot had obtained a suspension of a different length from the manufacturer and had replaced the suspensions at the launch site. In doing so, he had failed to secure the new suspension. It was fixed to the keel tube with just a Velcro strip. The Velcro held during the launch preparations and the take-off run, but came loose after take-off under the weight of the pilot.

*Figure 2: Accident configuration*

The suspension line for the connection to the harness (1) has not been threaded through the loop (2). The suspension line is not secured and is held in place only by the Velcro strip on the top of the keel tube (3). This Velcro strip is intended to secure the trim setting of the Atos. When a load is applied to the suspension, the Velcro comes undone and the suspension detaches from the glider. In the configuration without the canopy (as shown in the pictures) this error is very obvious and impossible to overlook.

The loop through which the harness connection is threaded is largely concealed as soon as the canopy is closed (zipper).

- It does not normally occur during normal use or operation, provided that no changes are made to the suspension.
- When the suspension is changed.
- If the Velcro strip on the keel tube and the safety Velcro (white) are opened to adjust the trim, the entire suspension system loosens and the connecting strap to the harness may slip out of the loop.

- All owners and pilots of an Atos (all models) are urged to familiarise themselves with the safety issue described.
- As described in the Atos operating manuals, the correct assembly of the suspension must be checked as part of the pre-flight check before every flight.
- Situations requiring the suspension to be dismantled or loosened: Particular care must be taken and the correct fitting of the suspension must be double-checked.

The manufacturer has been asked by the DHV to improve the suspension system on all Atos, both existing and new. Equipment owners and pilots are asked to check regularly for any safety warnings issued by A.I.R or the DHV.
