Safety Notice: Yeti Convertible 2

Check webbing connections

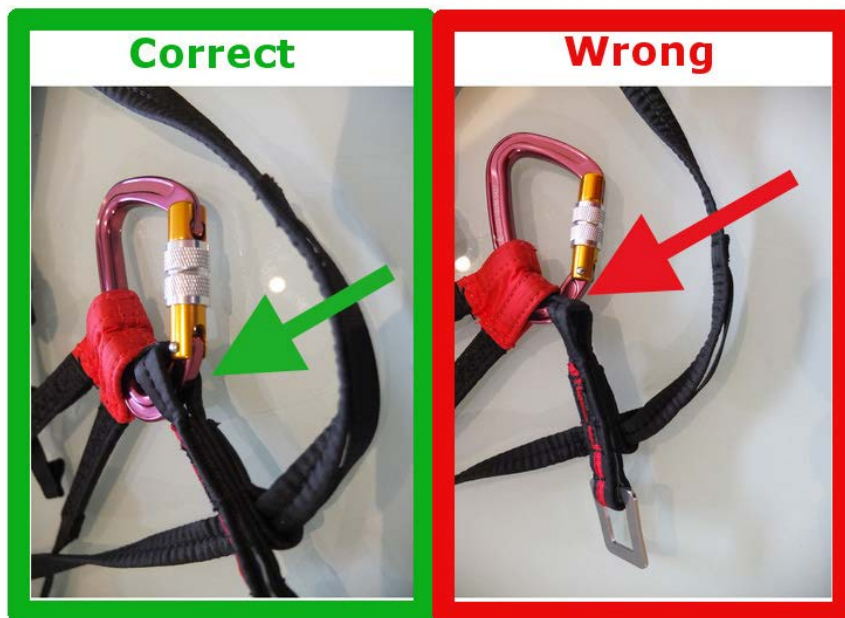
An incident was reported where the pilot took off with the webbing incorrectly attached to the main carabiner.

Pilots should check before their next flight that the webbing on their Yeti Convertible 2 is correctly connected through all 3 webbing loops, as shown in the photo below (and also in the manual).

If you are in any doubt about how to perform this check, please contact your dealer or school.
