## BREEZE2 SAFETY NOTICE

When installing the reserve system in the BREEZE2, the two white loops are threaded through the eyelet using a packing loop and then secured with the split pin system of the reserve handle.

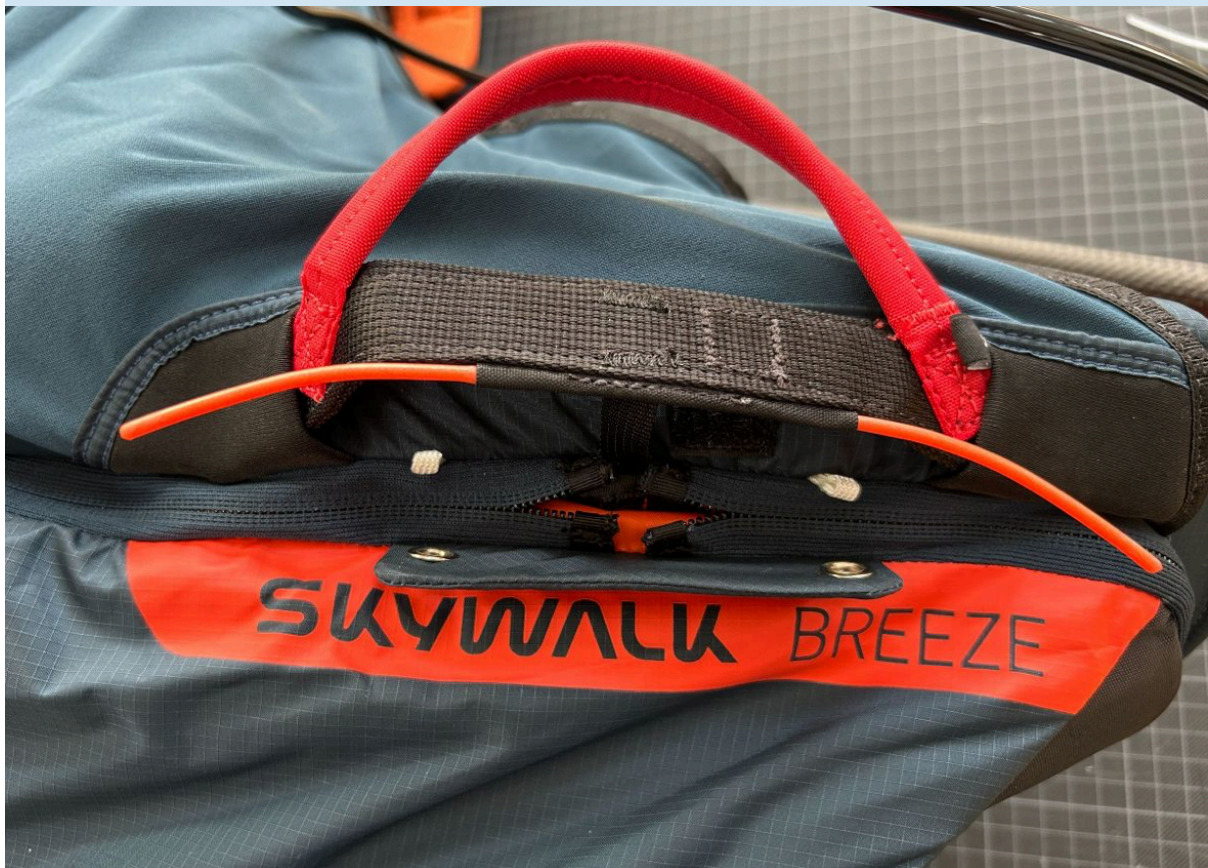
1. Open the cover.

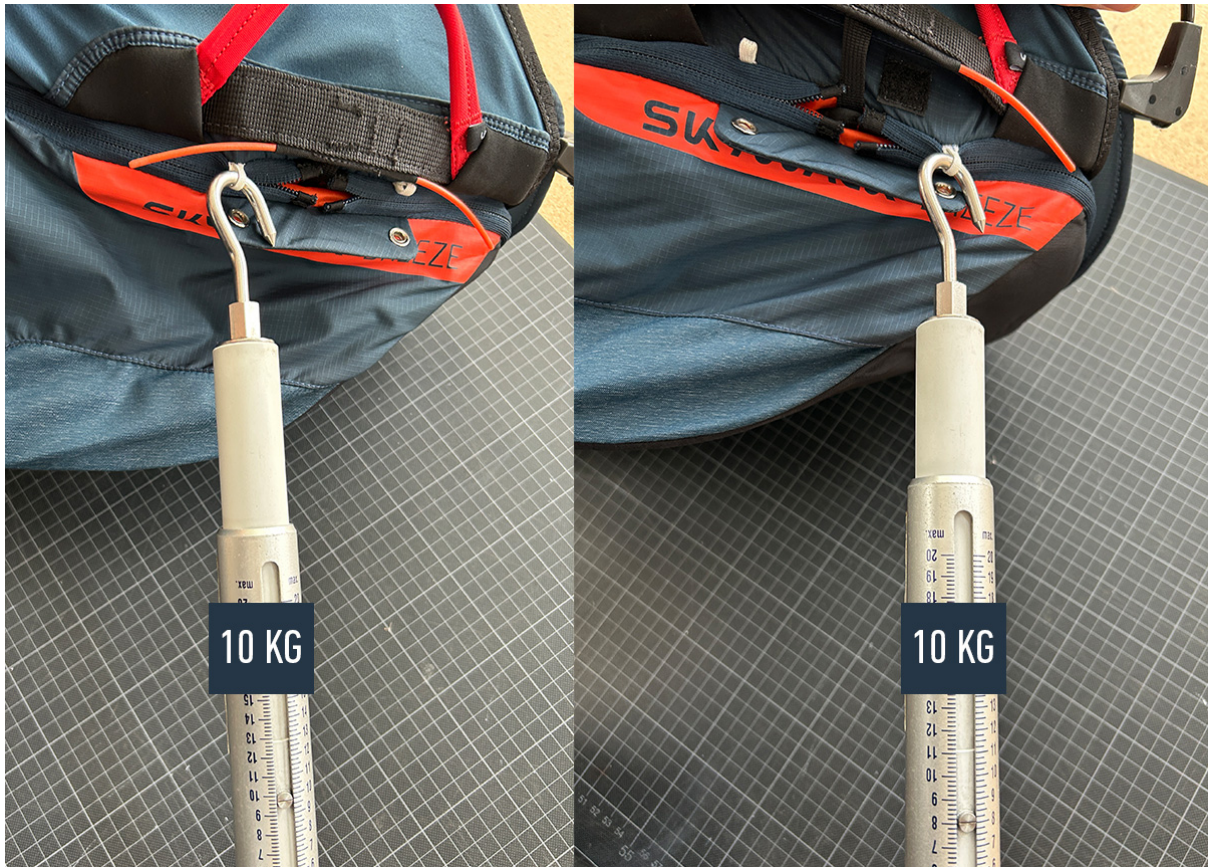
2. Tensile test on both rescue loops with 10 kg each.

If one of the white loops breaks during the tensile test and you consequently have a harness affected by the safety notice, please contact our support team immediately. You can easily reach them at **[support@skywalk.org](mailto:support@skywalk.org)** or via the phone number listed below.

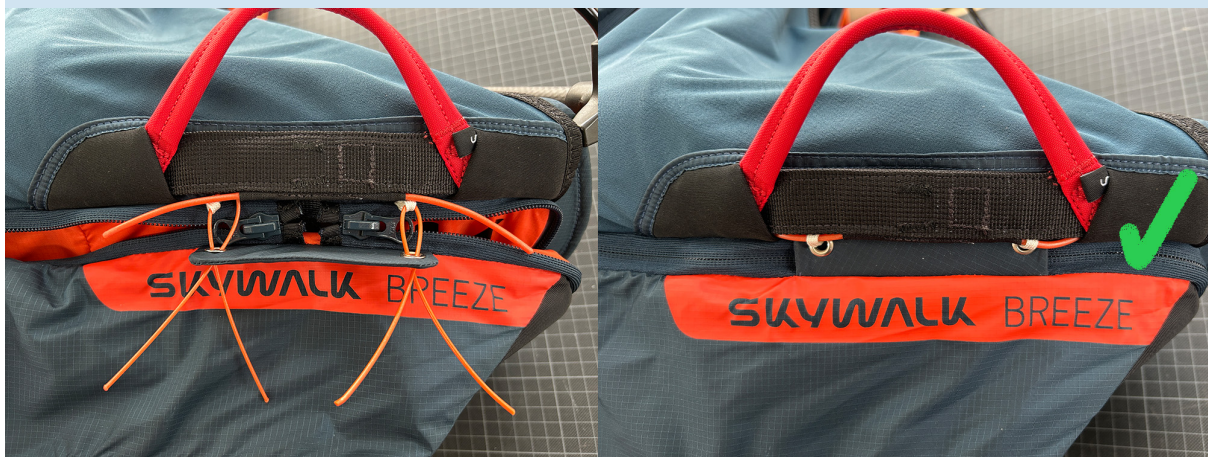
3. Follow the instructions in the manual for the rescue system installation.
