Investigation into incidents involving the Paralock 3 paragliding carabiner

The aim of the investigation was to find under what conditions the carabiner can open unintentionally and release the riser.

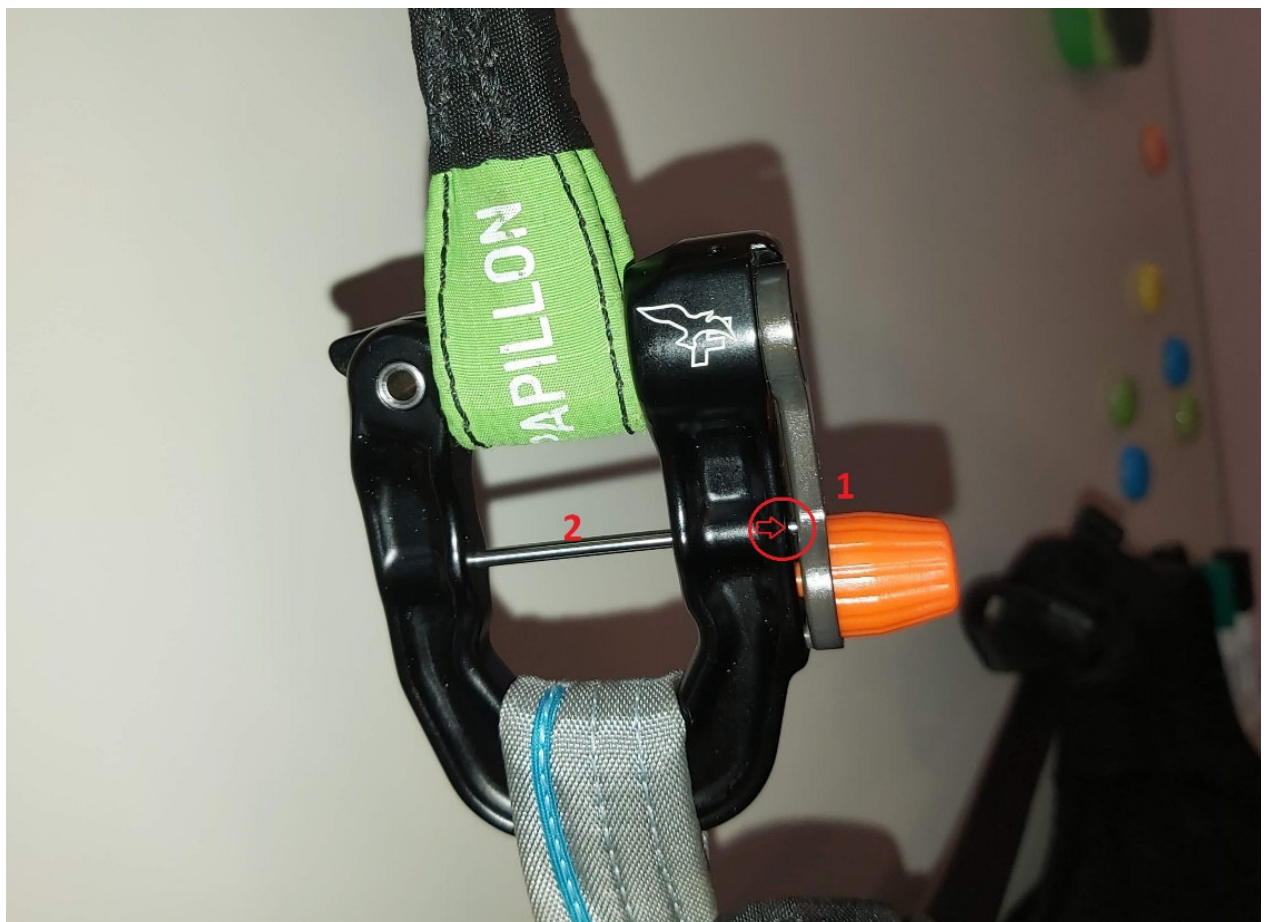
1. Correct assembly

If the release lever (1) is engaged in the lower position with an audible click and the securing pin (2) has been locked (circle), it cannot be opened unintentionally. The release lever cannot be operated with the release knob (orange) in this configuration.

This configuration is specified in the operating manual for all operating modes.

Caution! In previous manuals, operation without a locked securing pin was permitted for single-seat gliders but not for tandems.

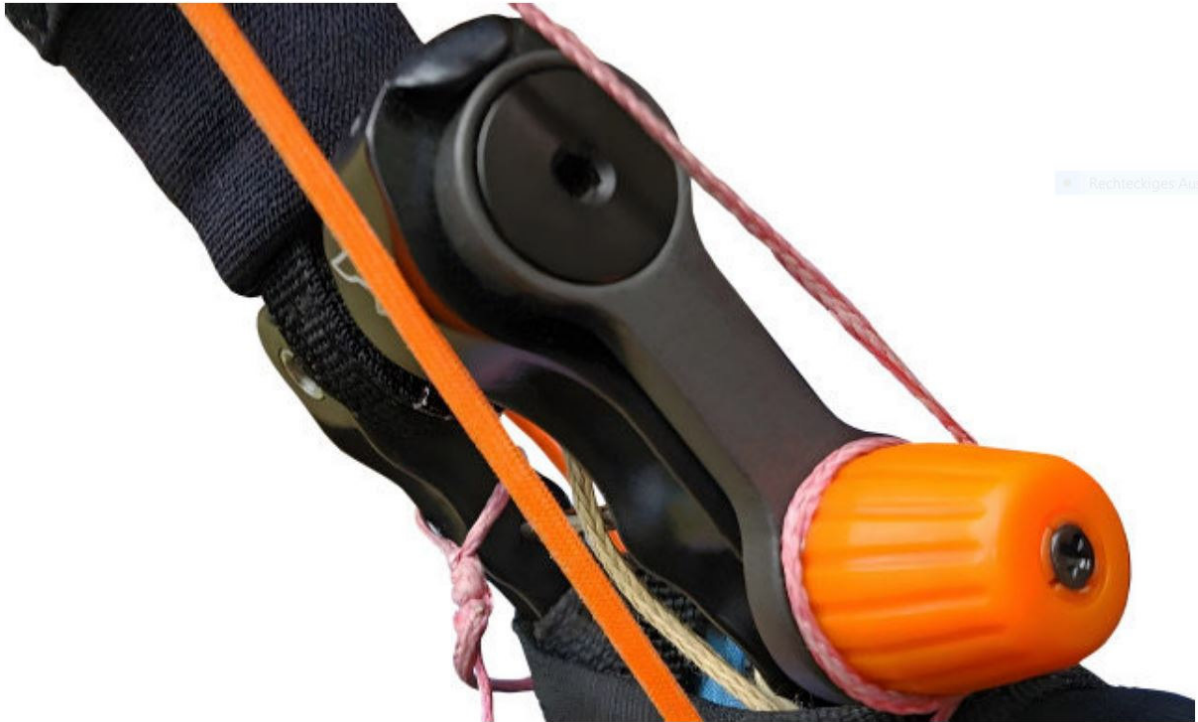
Illustration from the Finsterwalder safety note from 7 July 2024

A loose speed bar line was the cause of at least two of the reported incidents. The loose speed bar line wrapped around the release button of the release lever and, during subsequent acceleration, led to the activation of the release mechanism and opened the carabiner. The first incident was reported to the DHV on 21 June 2024 and led to a [safety note from Finsterwalder on 7 July 2024](#). The safety note stipulates that pilots may only use the Paralock with a locked securing pin. This applies to all operating modes of the carabiner. The second incident occurred on 20 July 2024.

1. The pilot must often move the release lever manually into the locked position, as it does not always snap in and lock automatically.
2. If lines are looping around the release knob and these lines are then getting tension/load, the release knob can open. With an unlocked securing pin, this can lead to an opening of the carabiner.
3. There is no option for the pilot to visually make sure if the securing pin is open or locked. The securing pin has no visual control to inform the pilot of the open or locked state.
4. Due to the delicate design of the securing pin, its operation requires increased attention, especially when wearing gloves.
5. Pilots can close the securing pin even if the release lever is not snapped shut and locked into place. This leads to the release lever being completely unsecured and able to easily open unintentionally.

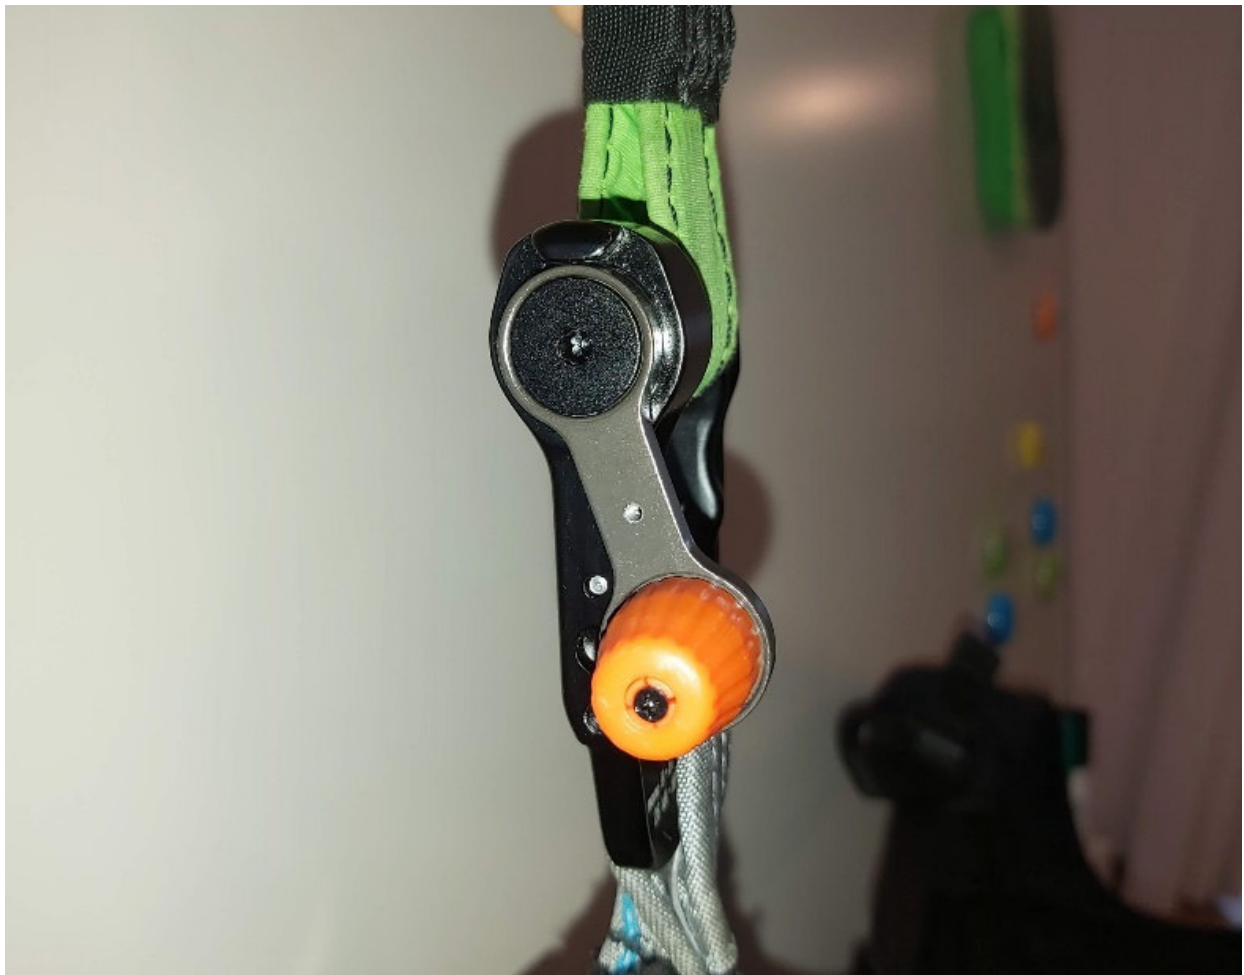
The spring of the release lever is not strong enough to ensure that it always snaps shut and locks into place automatically. [This video shows a demonstration](#). If the pilot lets the release lever go after attaching the riser, the spring force is sufficient to allow the lever to snap shut and lock into place in the lower position. However, if the pilot leads the release lever down slowly, it will not snap shut and lock into place by itself. In this case the pilot must move the release lever manually into the locked position.

Release lever not snapped shut and locked into place.

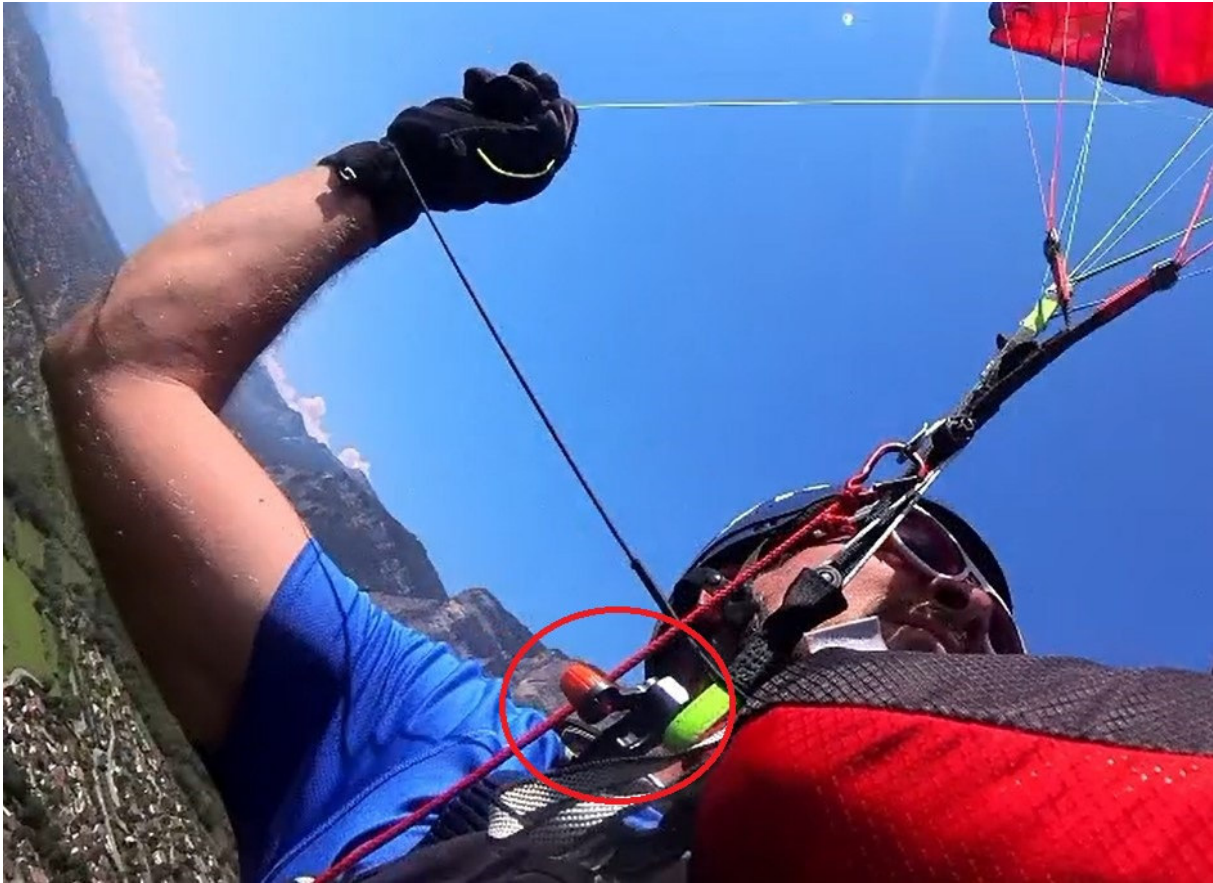
In this video freeze frame, you can see that the line of the speed bar is pushing the non-locked release lever. As the flight progresses, the speed bar line opened the Paralock 3. The pilot landed with the reserve parachute.

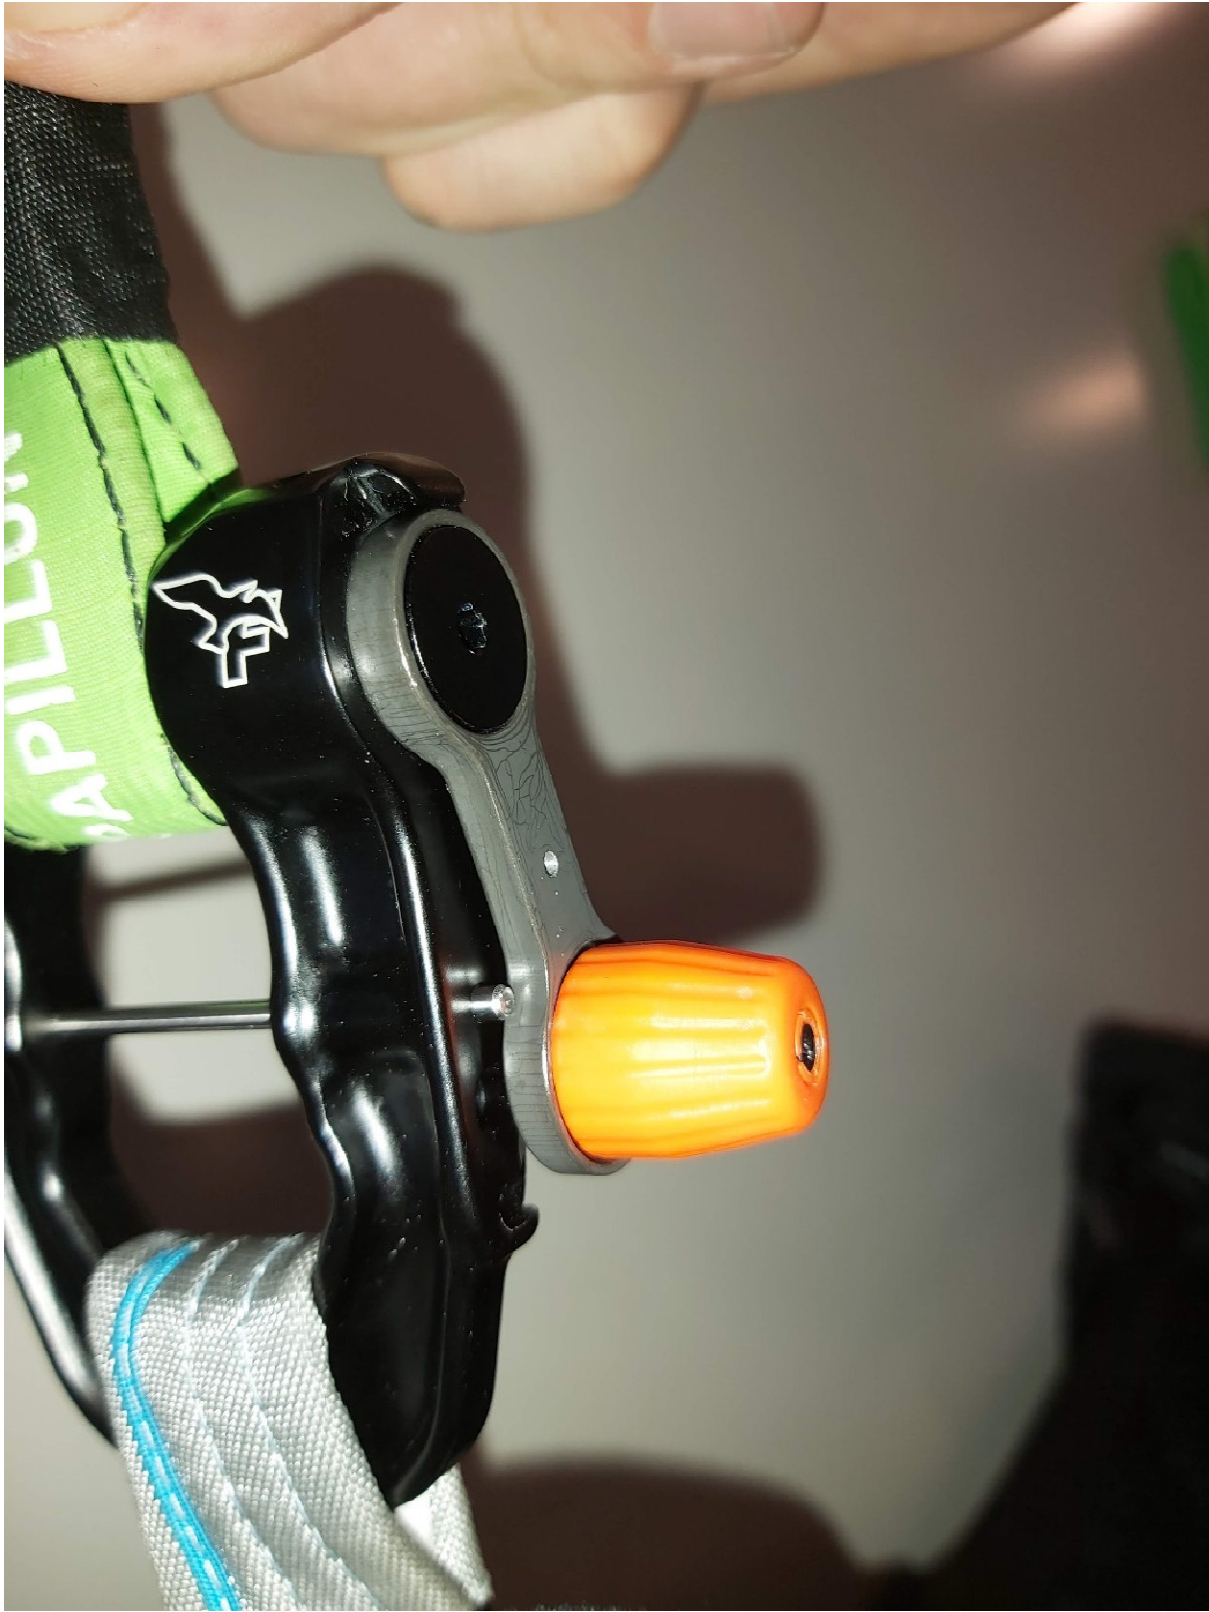
Pilots can push the securing pin into the locked position, even if the release lever is not snapped in. However, it then does not connect to the release lever and therefore does not secure it. Instead, the securing pin blocks the release lever in an unlocked position, where it is no longer able to snap shut and lock into place. The release lever remains completely unsecured. A little force, for example a steering movement, the line of the speed bar or low loaded lines after a collapse can move the release lever upwards unintentionally with little force and thus release the riser.
