Date, 28.06.2025

IMPORTANT INFORMATION regarding Icaro TANDEM SPREADER

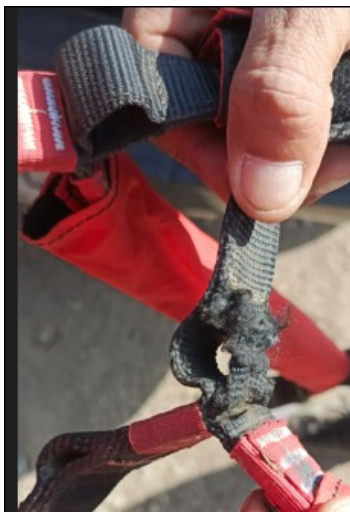
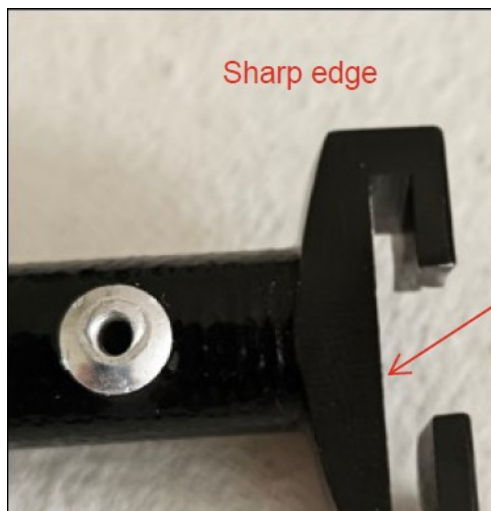
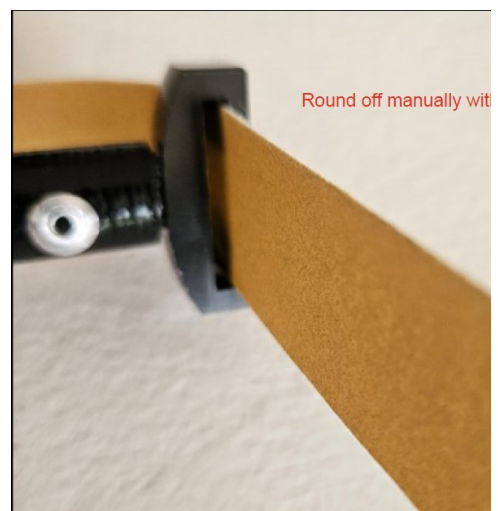
We have received feedback from a customer that problems have occurred with the tandem spreader. The reason is that the edges of the metal fitting on the carbon bar are too sharp, as they have not been deburred sufficiently. As a result, the webbing of the spreader can be damaged and, in the worst case, could be cut.

This only applies to spreaders from the batch from June 2024.

The spreader must be inspected for any damage as described above before the next flight:

- If there is no visible damage - please check the metal fittings of the carbon rod with regard to the edges and deburr the edges with sandpaper before the next flight.

- If there is visible damage to the spreaders, the spreaders must be replaced before the next flight.
